Subject: Rusting of Braking Surface

Products: All Vehicles with Disc Brakes

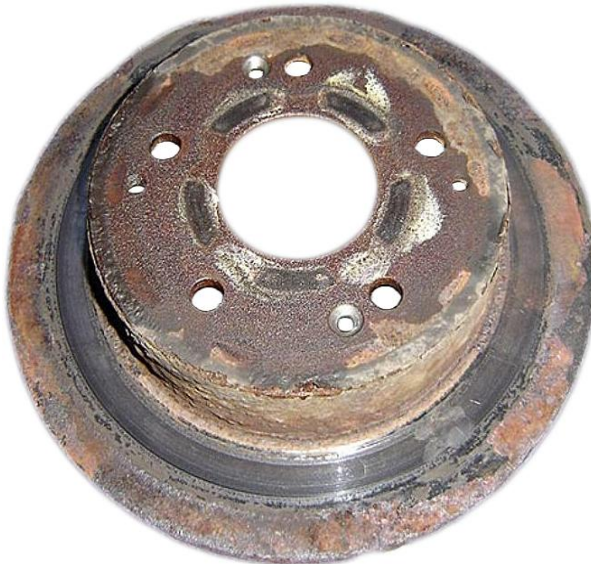
Concern: Rust on the braking surface of a rotor can be classified into 2 different categories: Rust Flaking (Left Image) and Rust Pitting (Right Image). It is important to understand the causes of the 2 different varieties of rust. Rust flaking is caused by a problem in the base brake system, not allowing the brake pads to fully contact the braking surface. Frozen or locked up caliper slides, a rusted caliper bracket or rusted anti-rattle clips will not allow the brake pads to slide freely. When the brake pads are not sliding freely, as much as 80% of the brake pad material may not make contact with the rotor. Rust then naturally appears in the metal, but is never cleared away by the brake pads.

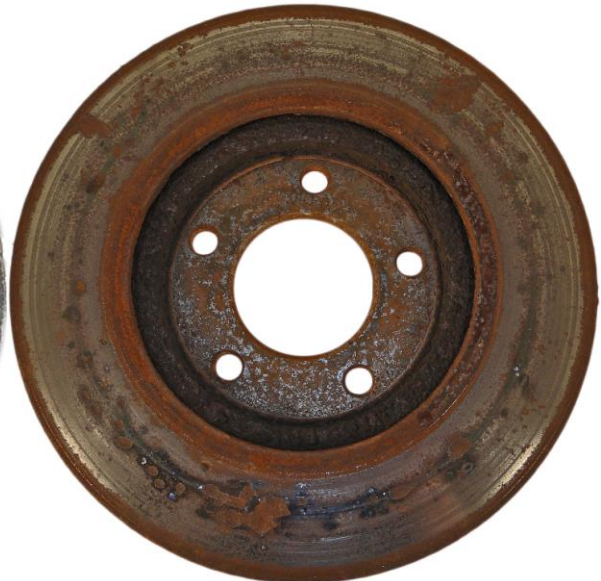
Rust Pitting

Rust pitting is caused by moisture in the brake pad material. The base brakes are working correctly, but due to moisture being held in contact with the rotor surface, small rust pits have formed. Under normal driving conditions the moisture and rust is cleared away. However, when a vehicle sits for extended periods or short trips are the norm, the moisture is never completely dissipated. The natural rusting process continues at an accelerated rate.
